Document Description: CSB-ELI Security-Improper Access Control	Document Number: 80029674 Version: B

<h2>Customer Service Bulletin</h2>	
Products: Welch Allyn ELI 150c, BUR 150c, Welch Allyn ELI 250c, Welch Allyn ELI 280, and Welch Allyn ELI 380 Resting Electrocardiographs	Date: 24-JUN-2022
Subject: Security Vulnerability of Improper Access Control	
HW Version(s) Affected: WLAN – 9910-023-06 (B&B)	SW Version(s) Affected: N/A
Serial Numbers Affected: N/A	Lot or Date Code Affected: N/A

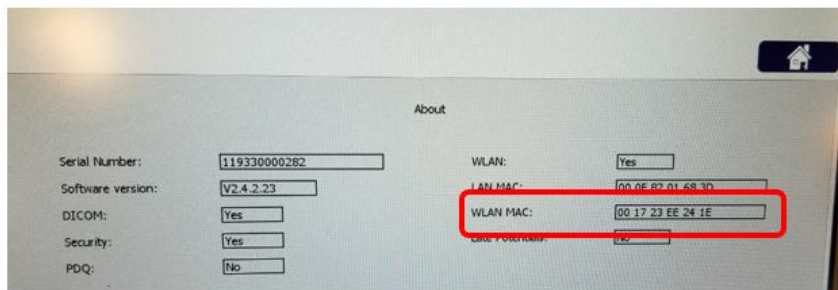
The WLAN MAC address is located under the SETTINGS function of the cardiograph, and will appear as shown below.

The MAC address contains 12 characters, where the first 6 characters are used to determine the model of the WLAN module installed. The remaining 6 digits will change with each device.

B&B module = 00 0B 28 xx xx xx

Laird module = 00 17 23 xx xx xx
